Performance Assessment and Evaluation of Hydrophobic and Ultraviolet Protective Treatments for Historic Log Structures

Courtney Magill
University of Pennsylvania

Magill, Courtney (2015). *Performance Assessment and Evaluation of Hydrophobic and Ultraviolet Protective Treatments for Historic Log Structures*. (Masters Thesis). University of Pennsylvania, Philadelphia, PA.

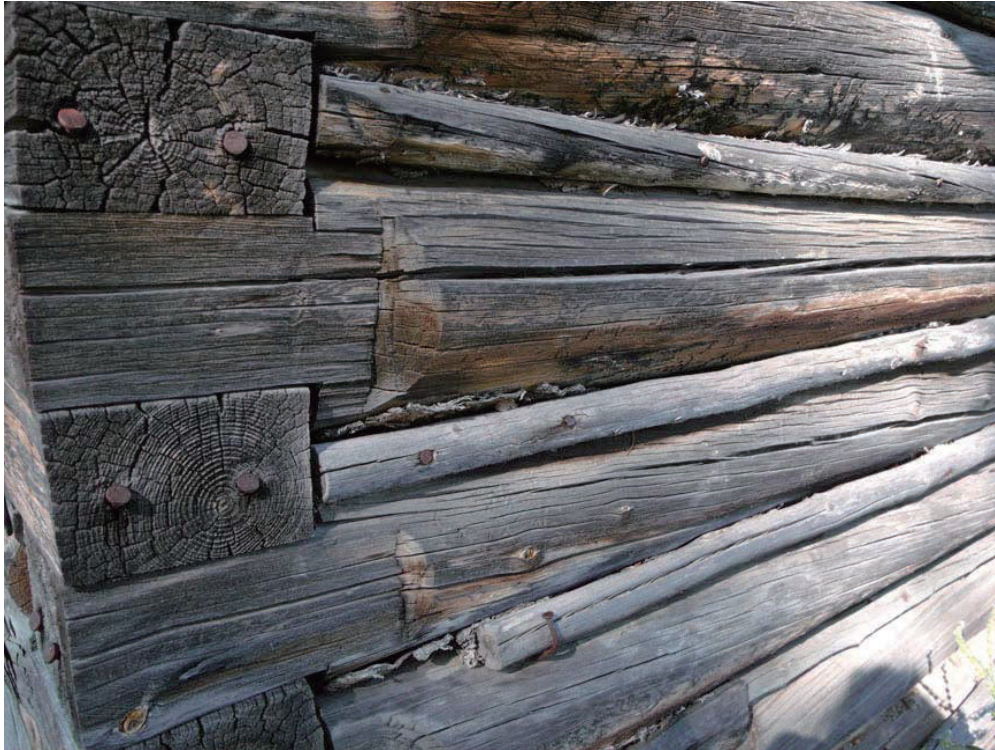
Figure 2. Notched construction seen on the Main Cabin. Photograph by Christine Leggio for the Bar BC Condition Assessment and Report, 2011 by the Architectural Conservation Laboratory.

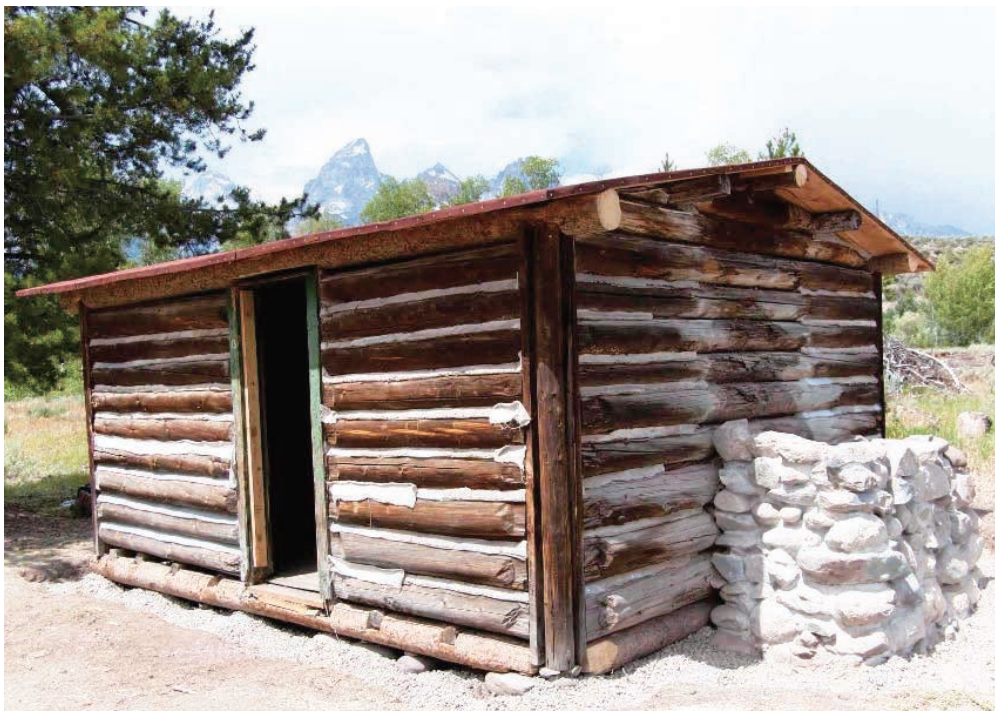
Figure 3. Hogtrough construction seen on a Dude Cabin. Photograph by the author.

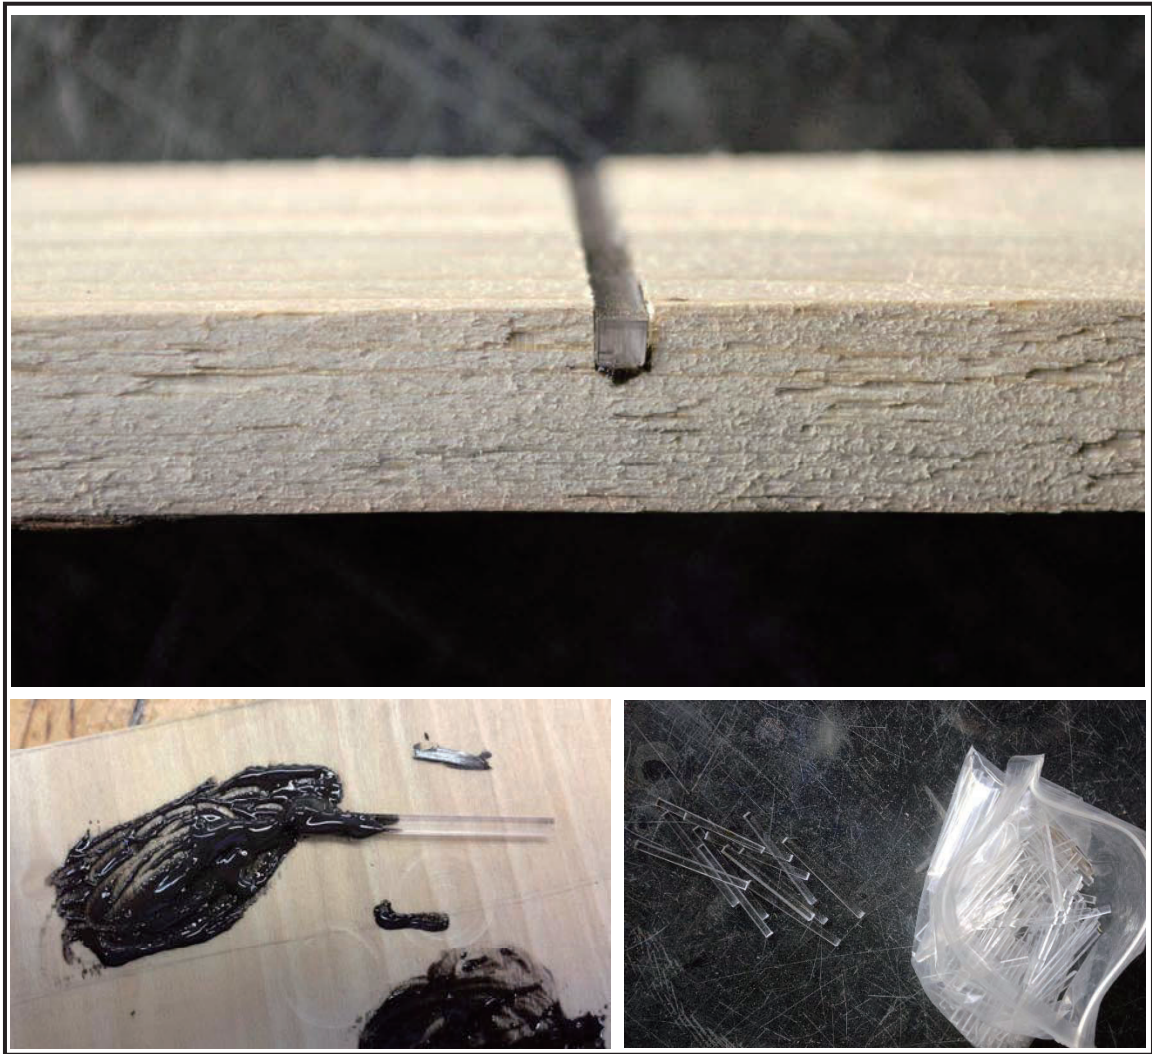
Figure 11. A sheet of neoprene was cut with a Universal Laser Systems laser cutter into small strips and inserted into a 1/8" deep cut between the smaller wood samples with J.B. Weld epoxy in an effort to separate the samples and prevent material from the top samples contaminating that on the bottom. Photographs by author.

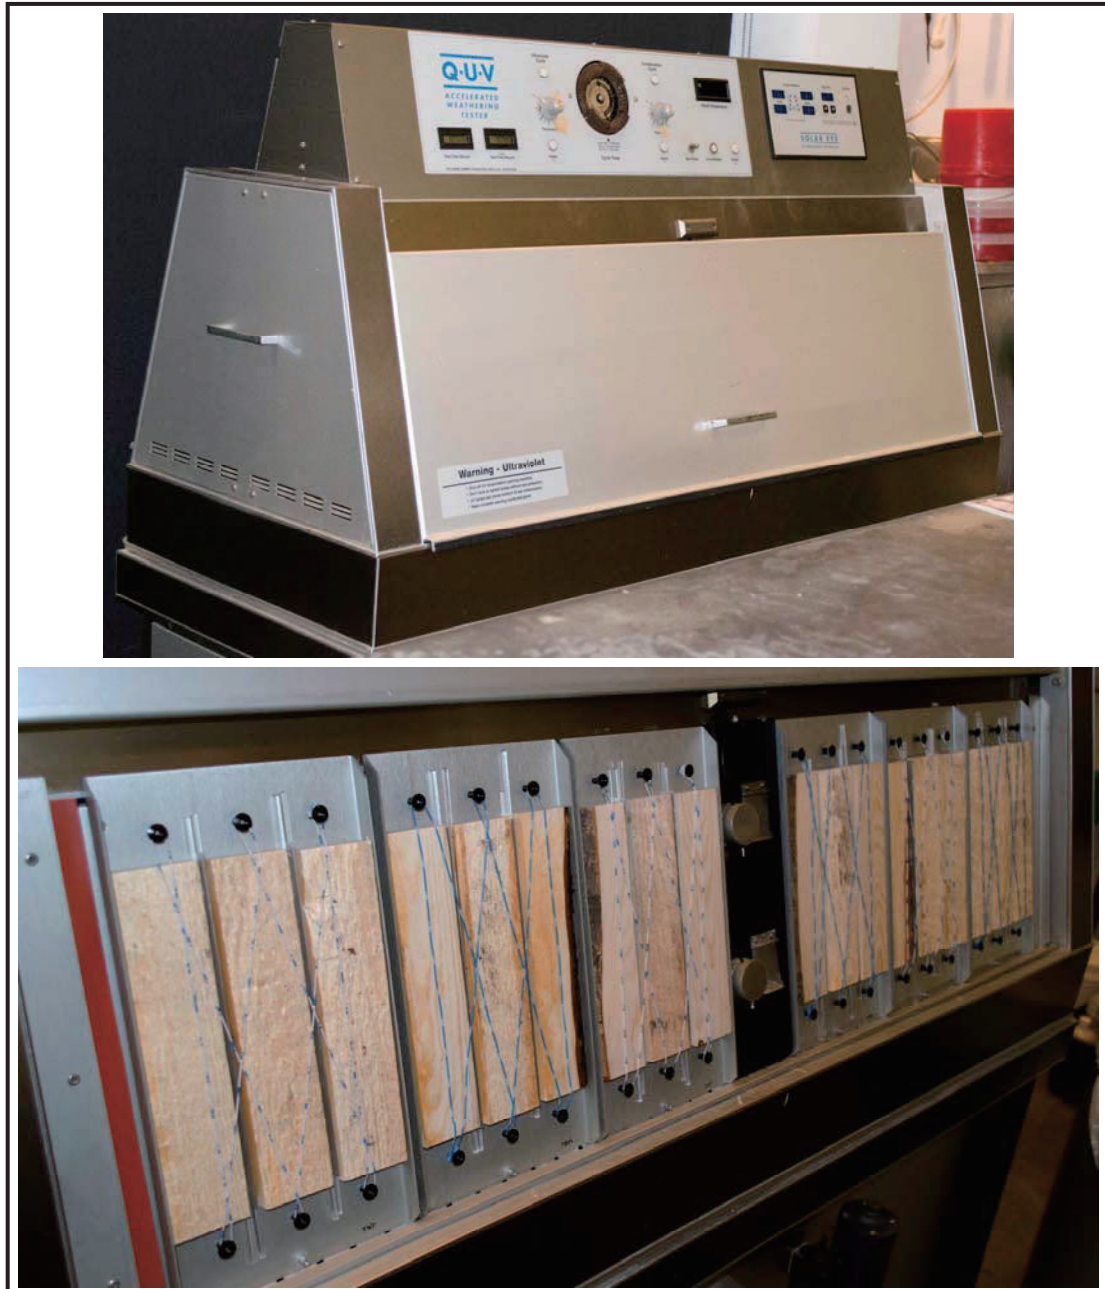
Figure 29. The QUV Weatherometer in the Architectural Conservation Laboratory both closed (left) and opened with specimen brackets inserted (right). Photographs by author.

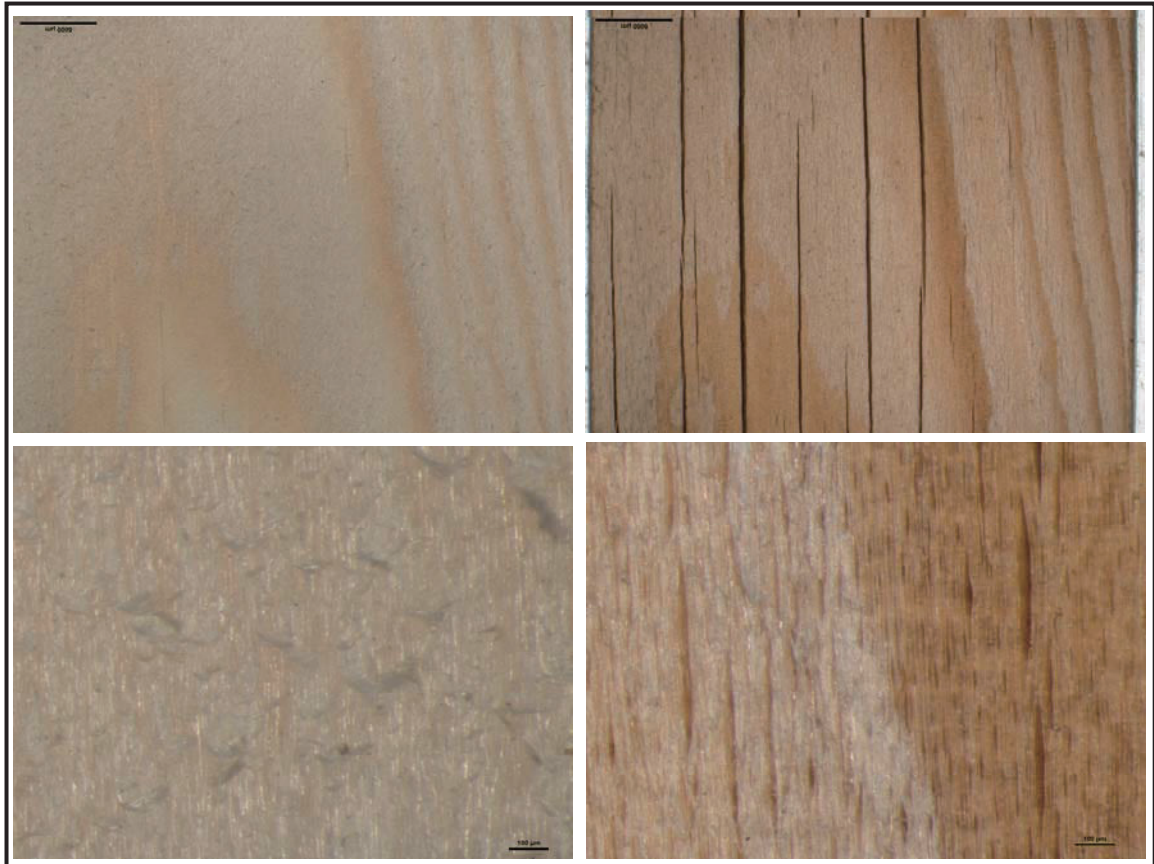
Figure 31. Control Sample 4 before (left) and after (right) weathering at 1x magnification (above) and 10 x magnification (below). Photographs by author.

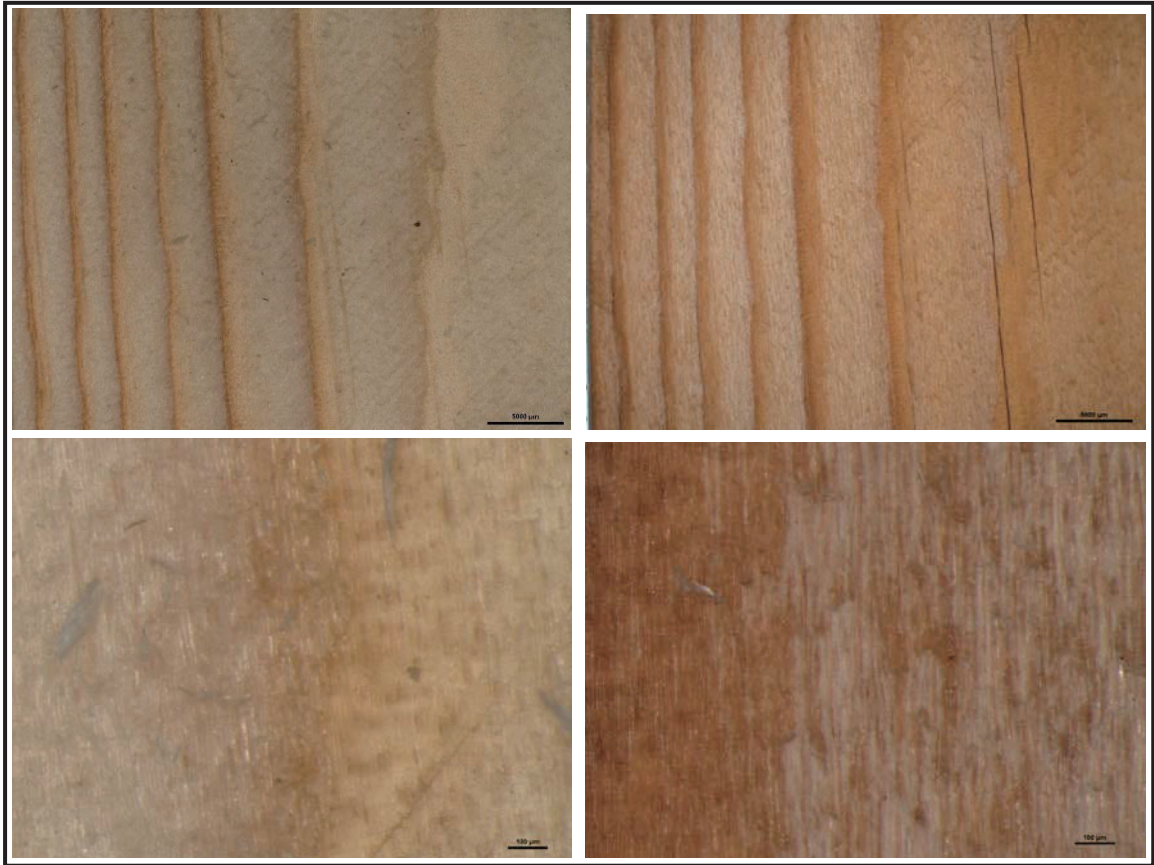
Figure 32. Linseed Oil Sample 3 before (left) and after (right) weathering at 1x magnification (above) and 10 x magnification (below). Photographs by author.

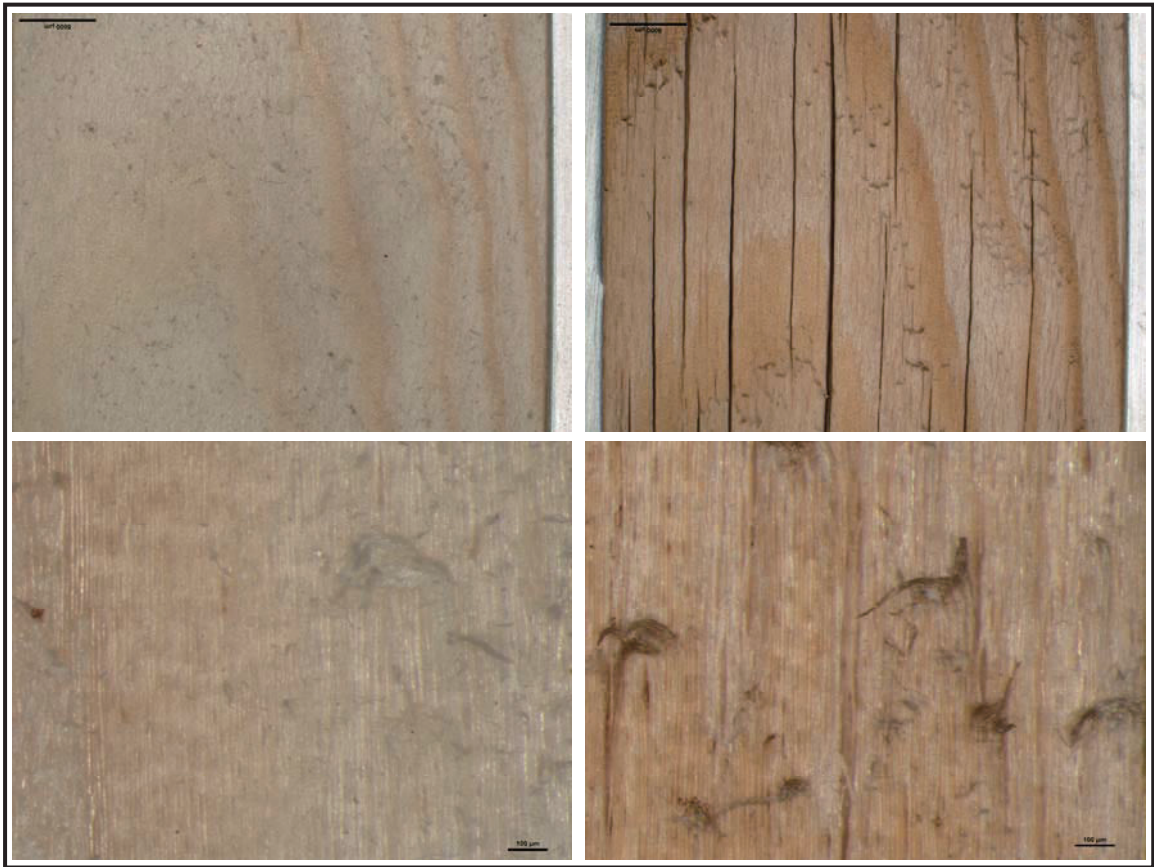
Figure 34. Paraffin and Mineral Spirits Sample 2 before (left) and after (right) weathering at 1x magnification (above) and 10 x magnification (below). Photographs by author.

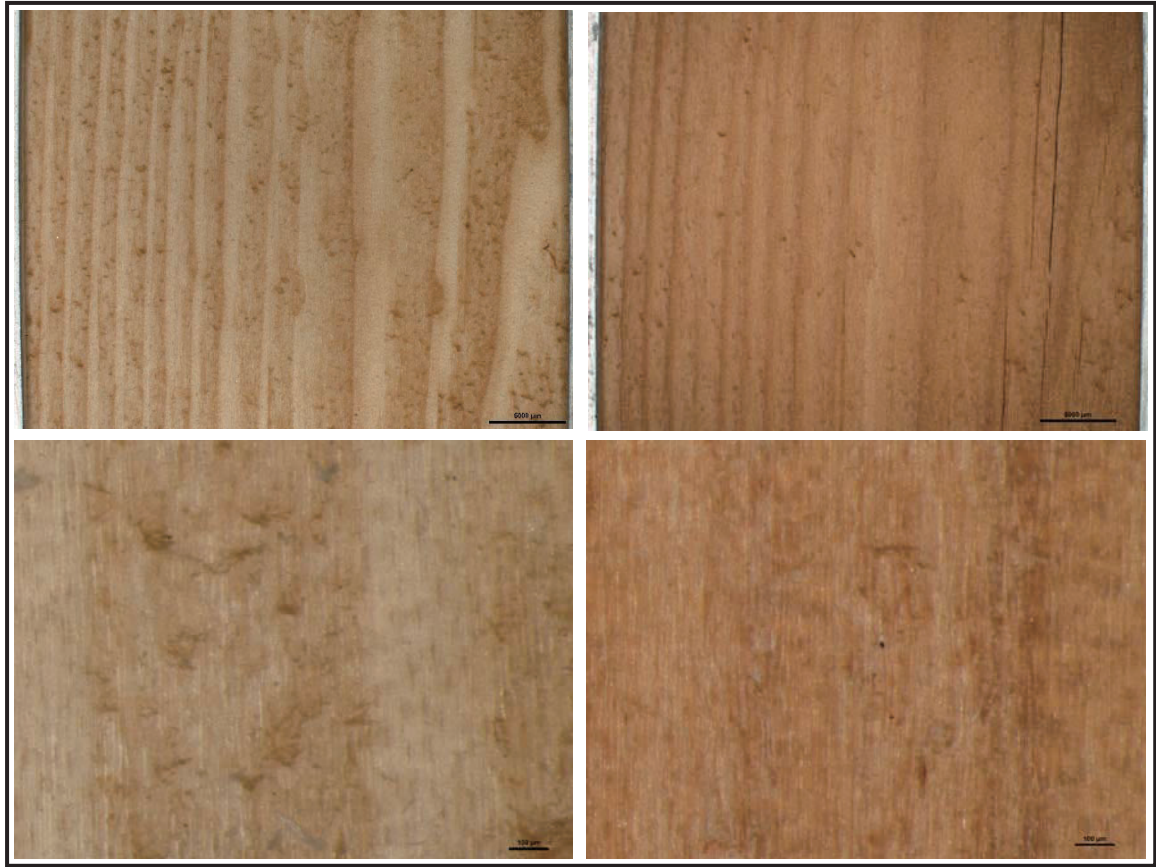
Figure 40. TWP 1500 Series Sample 5 before (left) and after (right) weathering at 1x magnification (above) and 10 x magnification (below). Photographs by author.

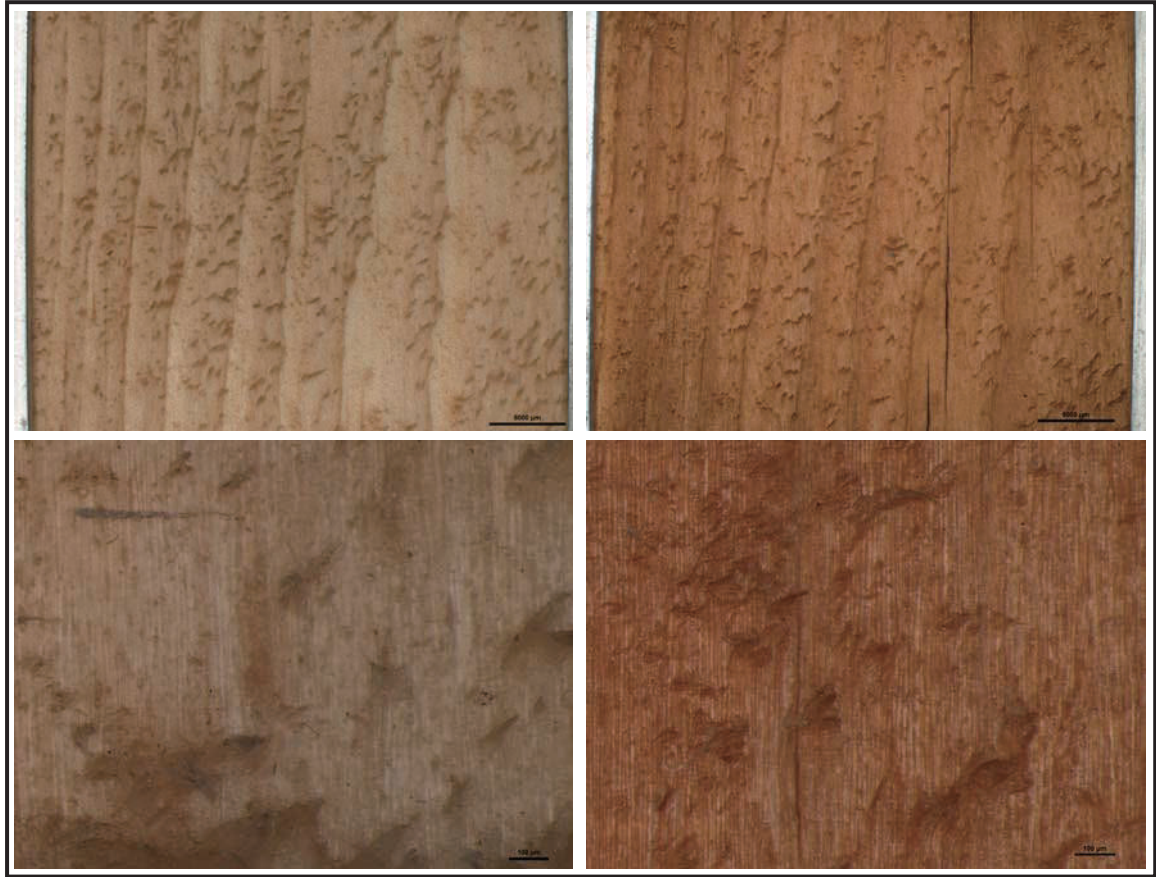
Figure 42. Flood CWF-UV 5 Sample 5 before (left) and after (right) weathering at 1x magnification (above) and 10 x magnification (below). Photographs by author.

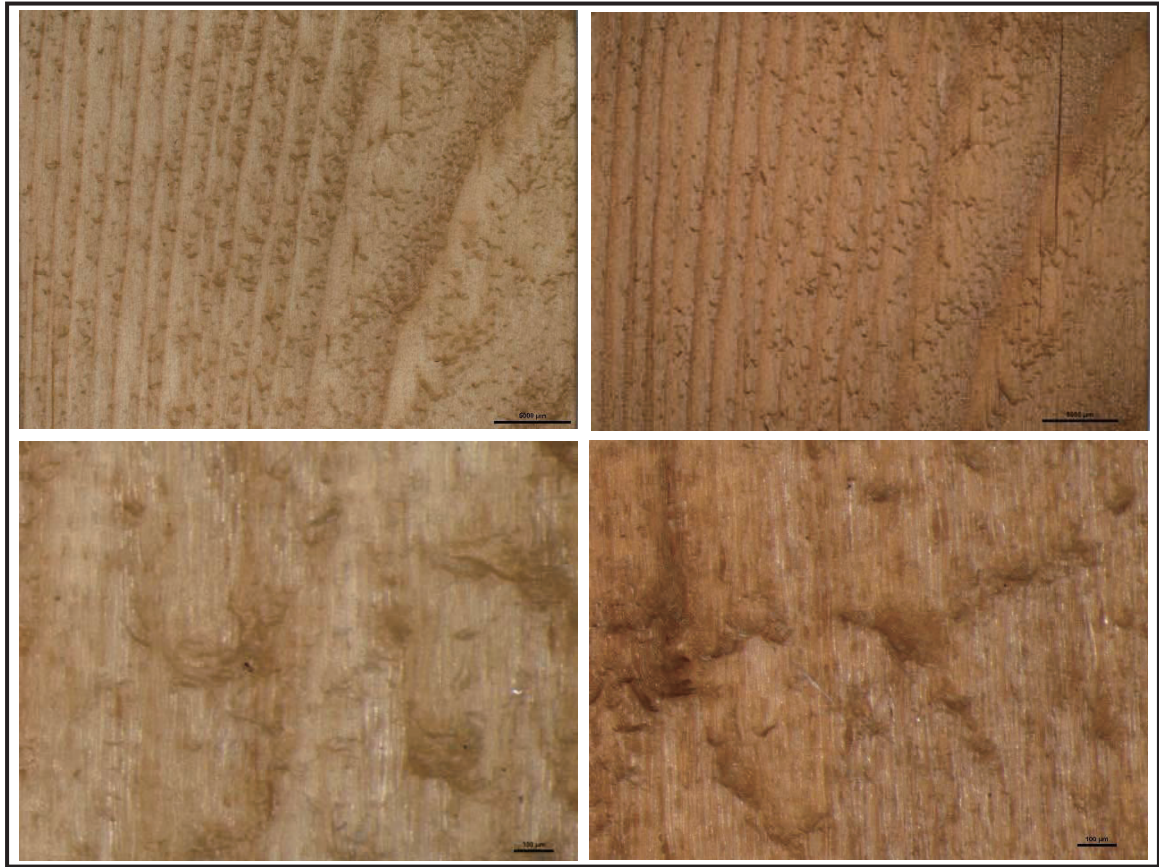
Figure 44. Messmer's UV Plus Sample 1 before (left) and after (right) weathering at 1x magnification (above) and 10 x magnification (below). Photographs by author.

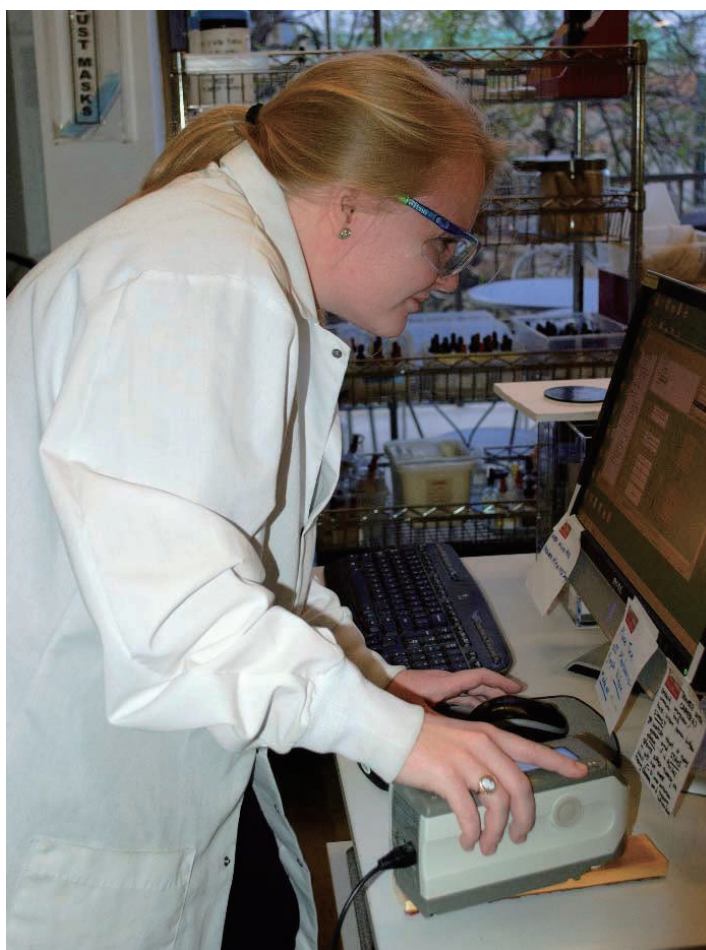
Figure 46. Taking color measurements using the Konica Minolta Spectrophotometer in the Architectural Conservation Laboratory. Photograph by the author.

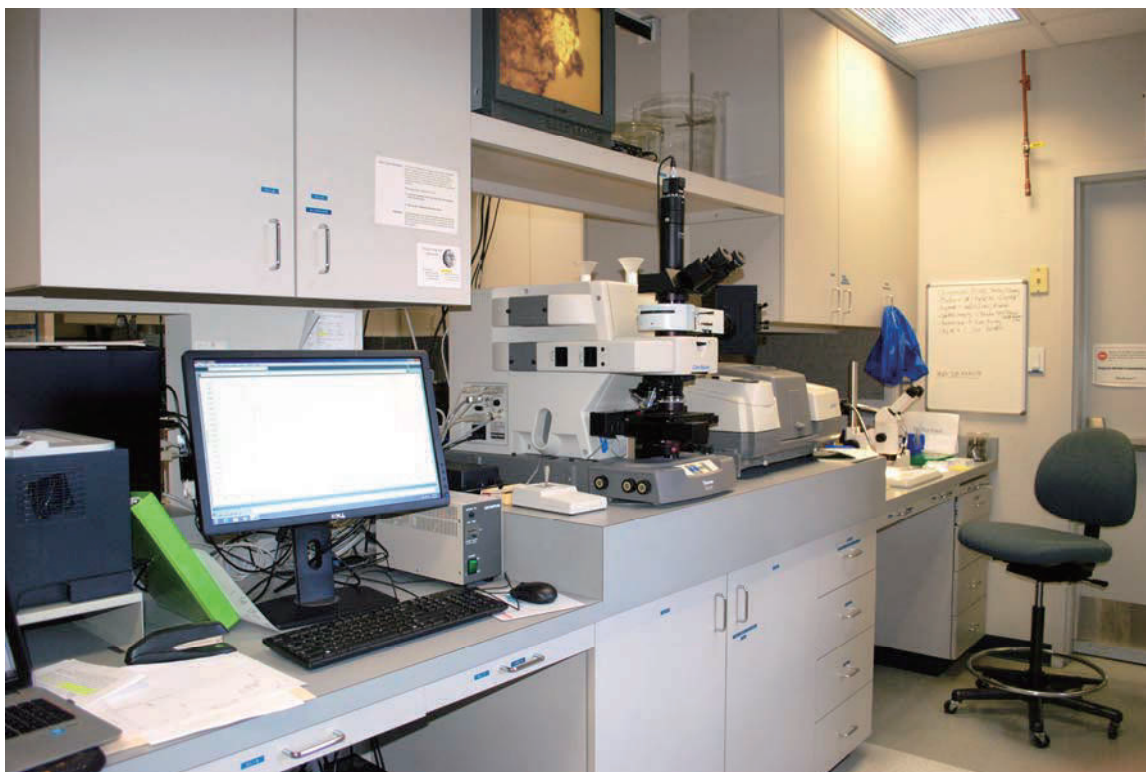
Figure 47. The FTIR arrangement in the Philadelphia Museum of Art. Photograph by the author.

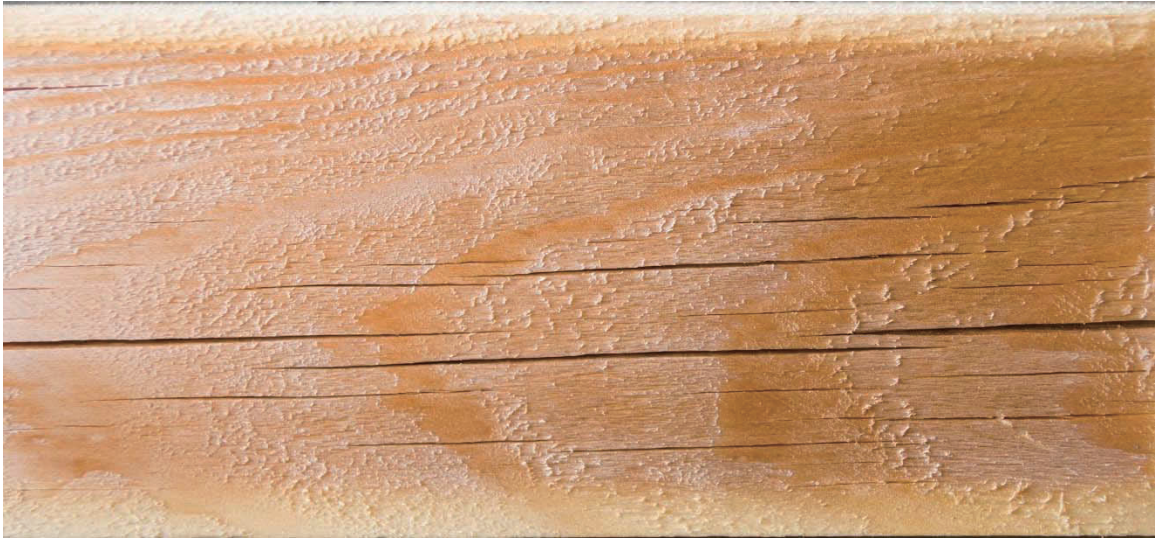
Figure 57. Example of the typical symptoms exhibited by a weathered sample. This sample has checks ranging from very small to large, a roughened earlywood surface, and raised latewood grain. Color change is apparent at the bottom of the photograph from where the bracket covered the sample and protected it from UV degradation. Photograph by author.

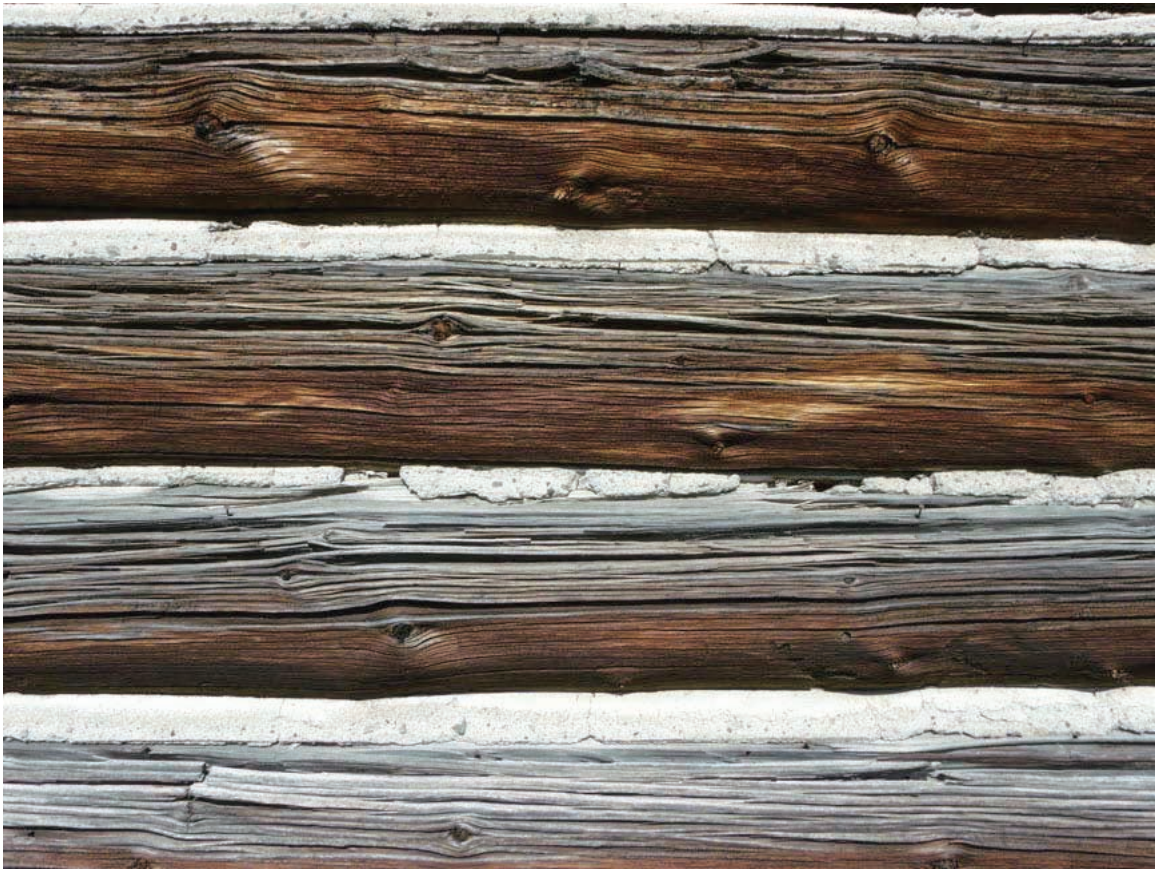
Figure 58. Extant Logs found at the Bar BC Dude Ranch displaying a range of coloration. Photograph by Christine Leggio for the Bar BC Condition Assessment and Report, 2011 by the Architectural Conservation Laboratory.
